NONDESTRUCTIVE TESTING OF DIFFUSION BONDED TITANIUM  
ALLOYS FOR ENGINE AND AIRFRAME COMPONENTS

**AFML-TR-74-215**

*FORT WORTH DIVISION  
GENERAL DYNAMICS CORPORATION*

**AIR FORCE MATERIALS LABORATORY  
AIR FORCE SYSTEMS COMMAND  
WRIGHT-PATTERSON AIR FORCE BASE, OHIO 45433**

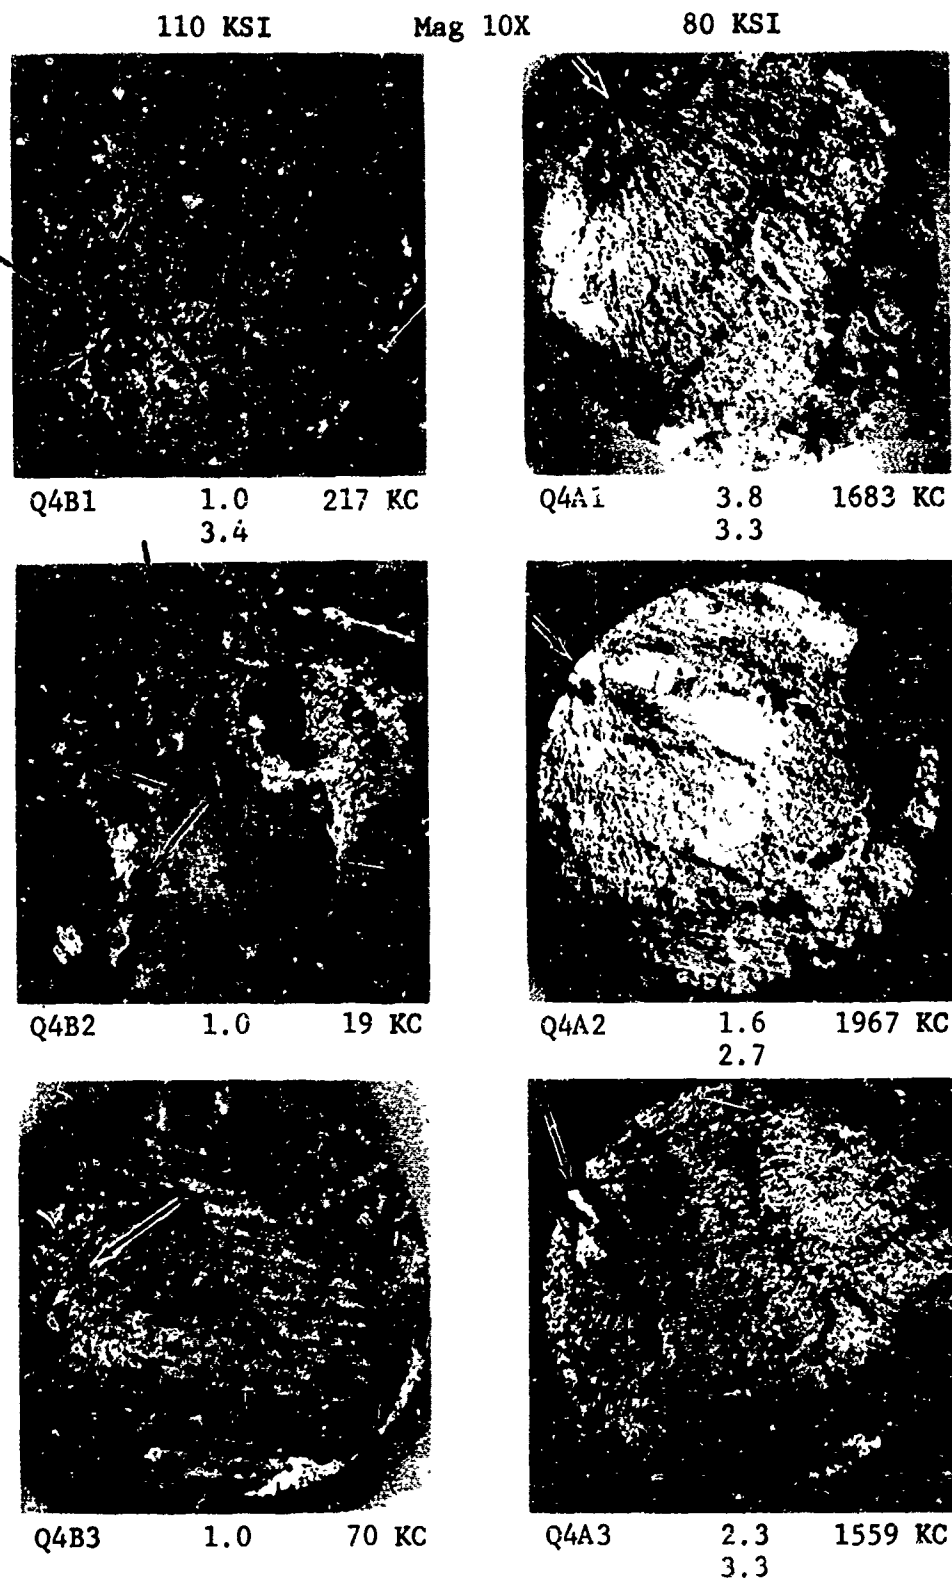
Figure 8.39 Fracture Surfaces of Failed Fatigue Specimens Series Q4-  
Double-Bond/Single-Axis Diffusion Bonded - ASTM Grain  
Size No. 9

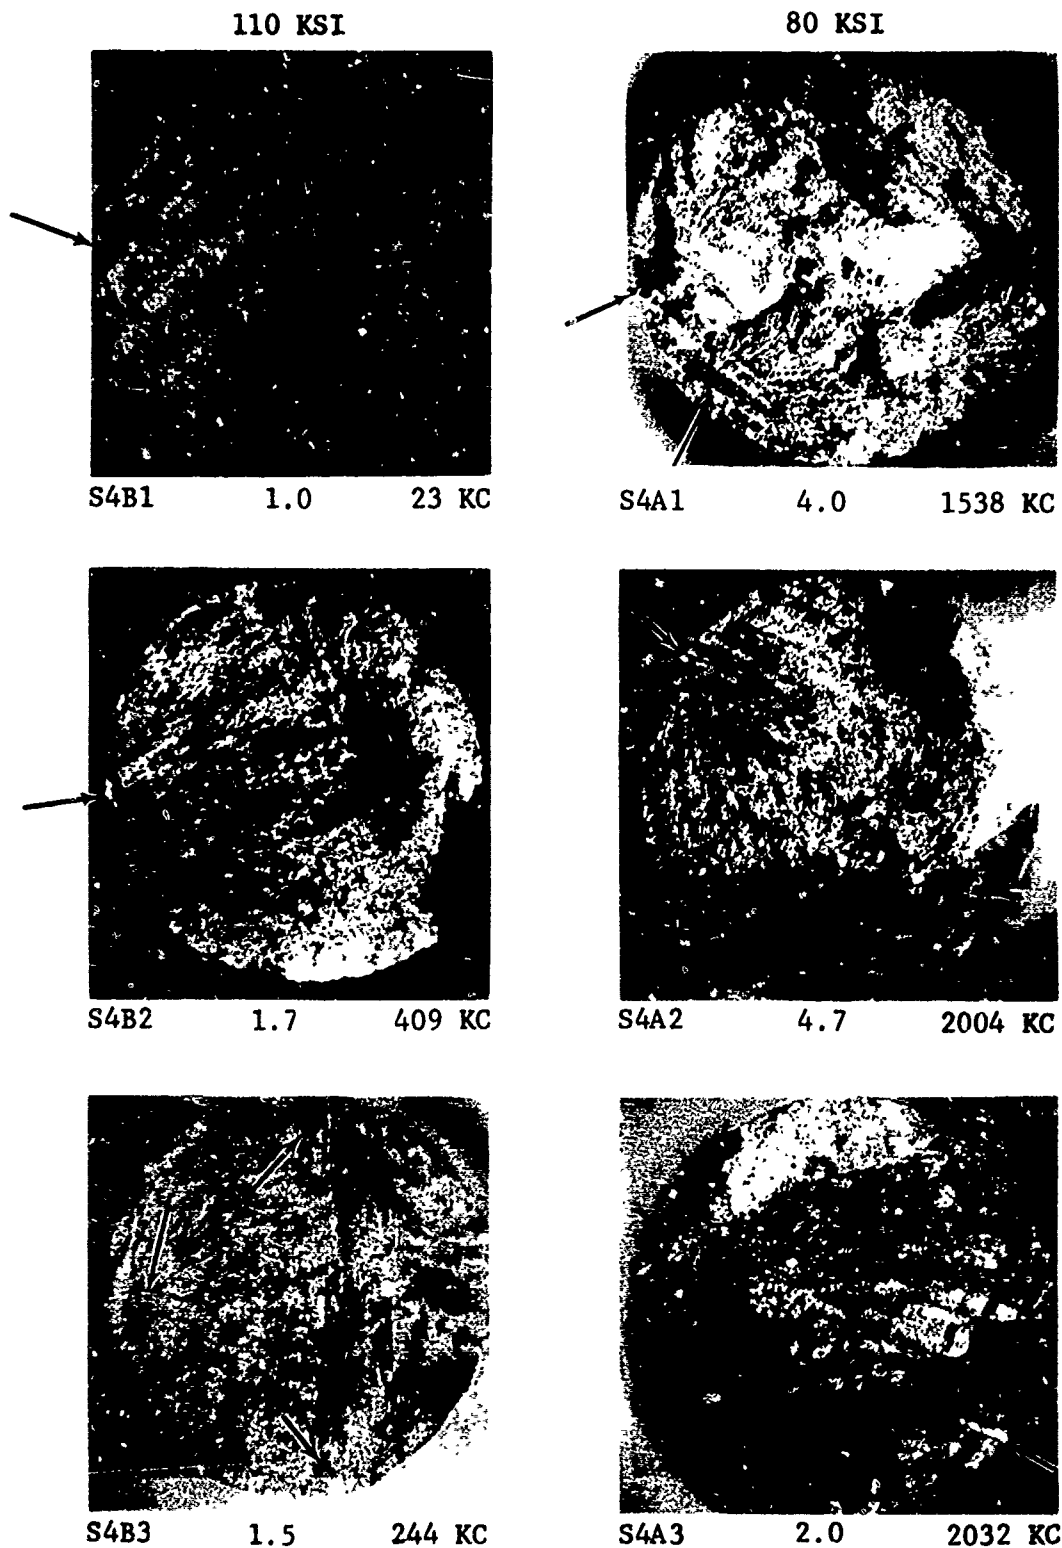
Figure 8.41 Fracture Surfaces of Failed Fatigue Specimens Series S4-Double-Bond/Single-Axis Diffusion Bonded with Multiple 0.0065" Dia. Surface Voids

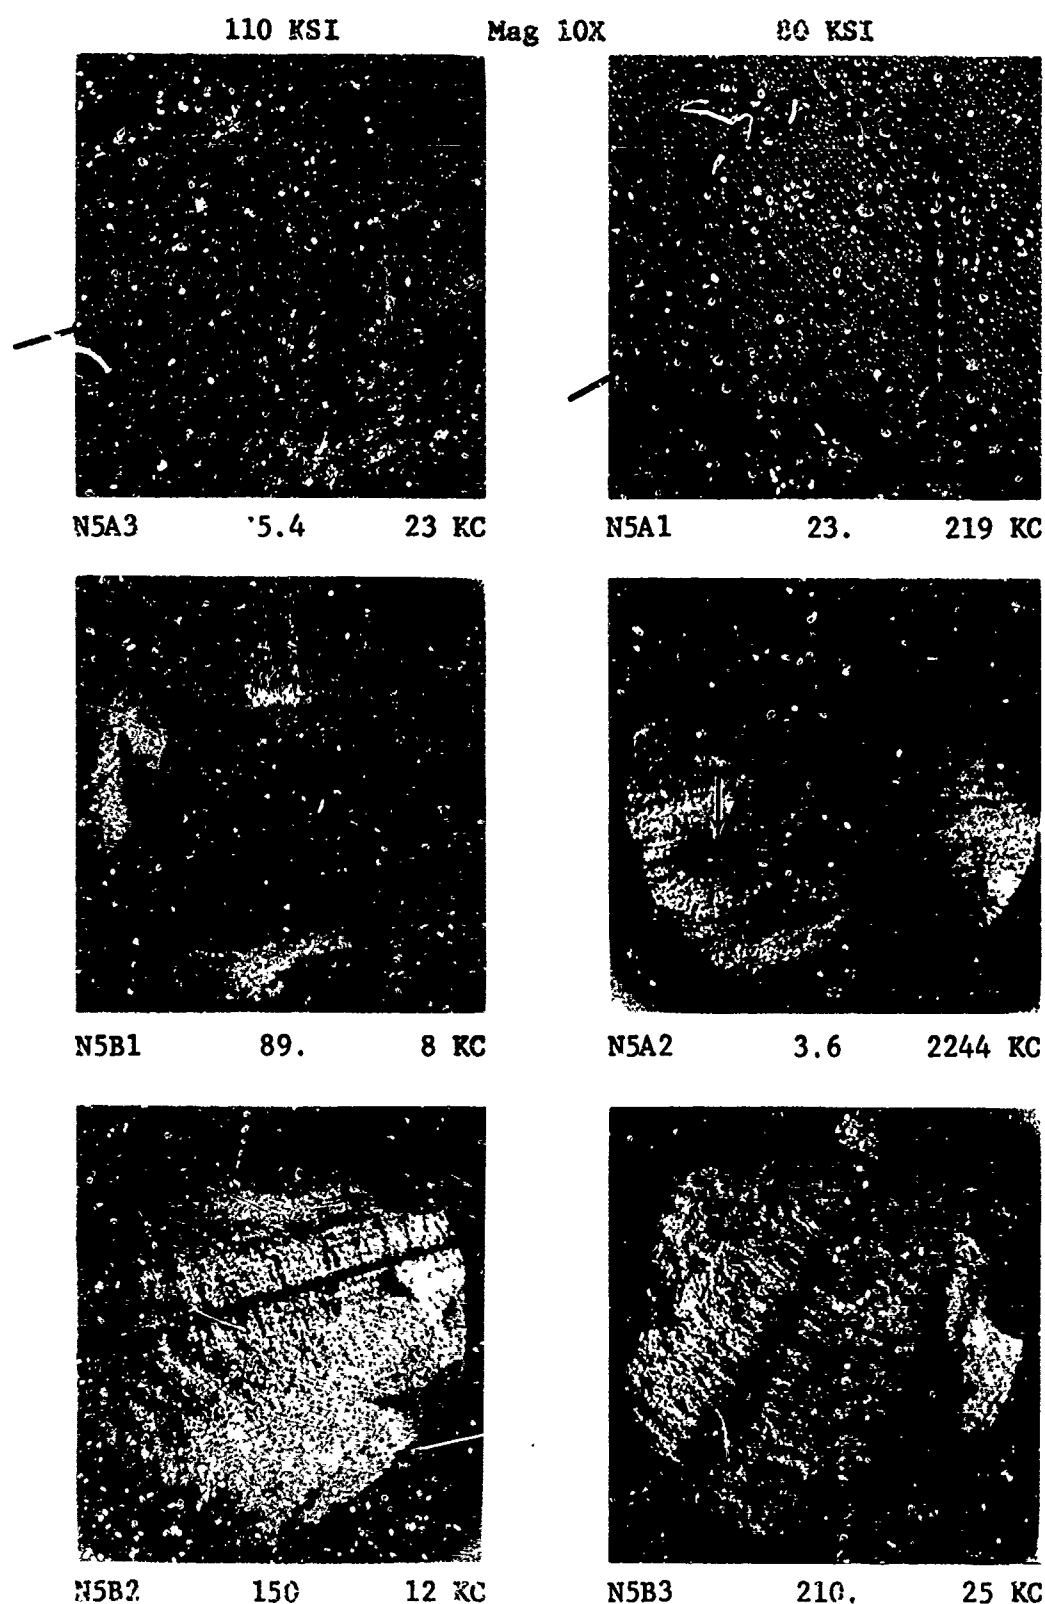
Figure 8.49 Fracture Surfaces of Failed Fatigue Specimen Series N5-Double-Bond/Two-Axis Diffusion Bonded with "Less than Optimum" Deformation

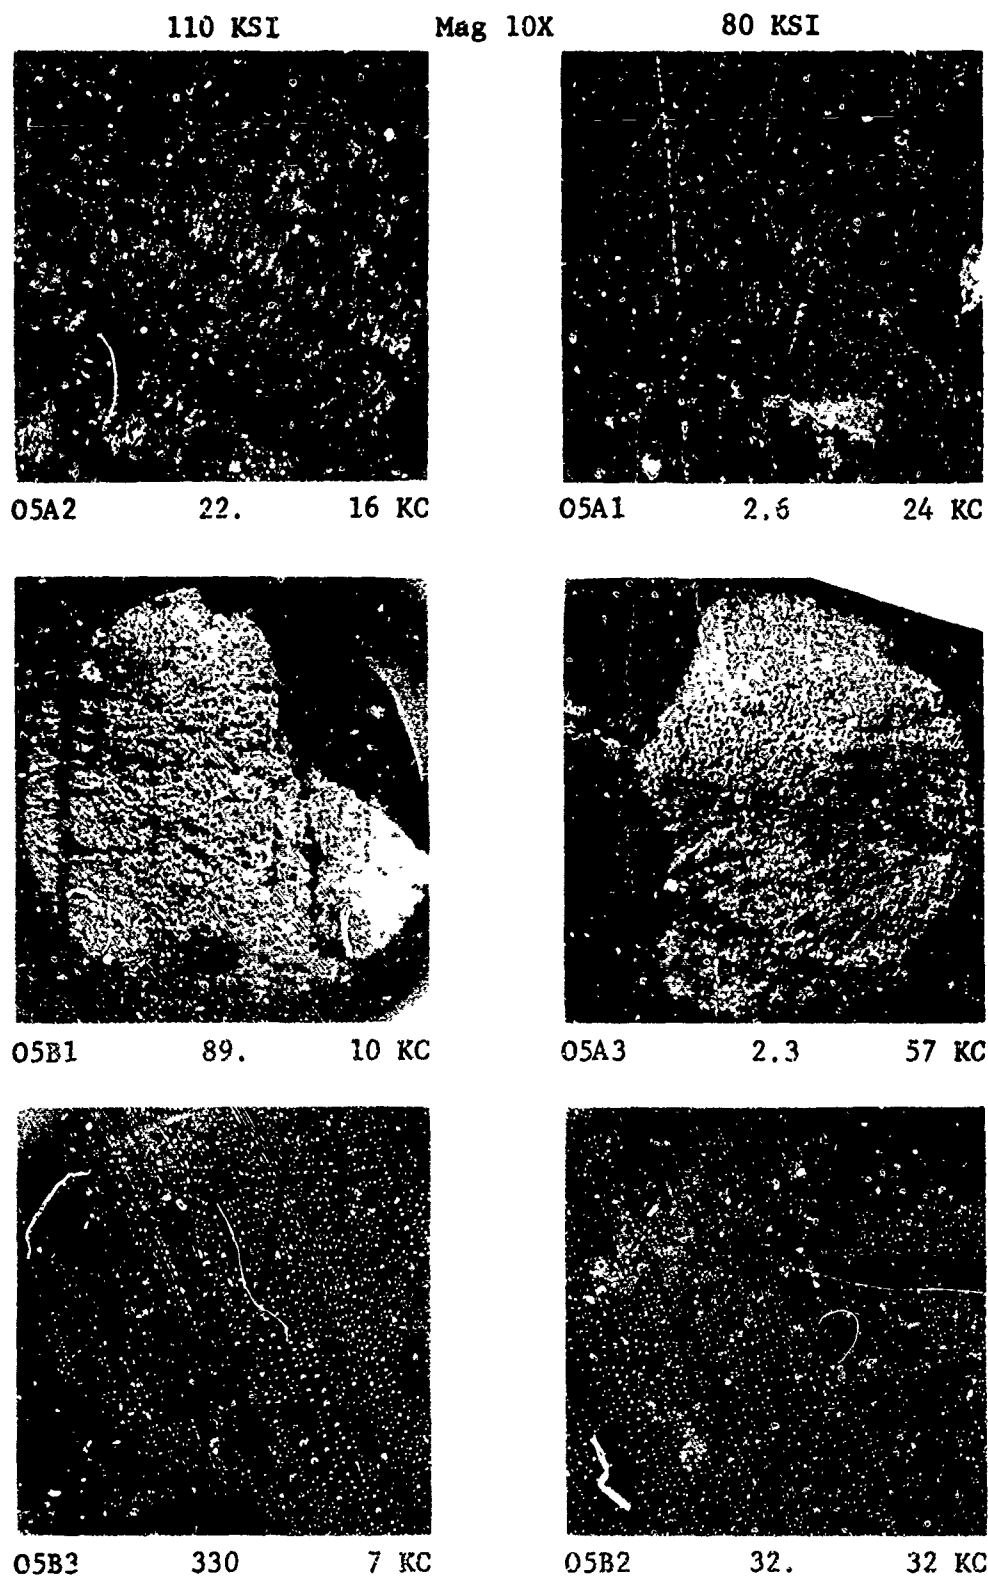
Figure 8.50 Fracture Surfaces of Failed Fatigue Specimens Series 05-Double-Bond/Two-Axis Diffusion Bonded with "Much Less than Optimum" Deformation

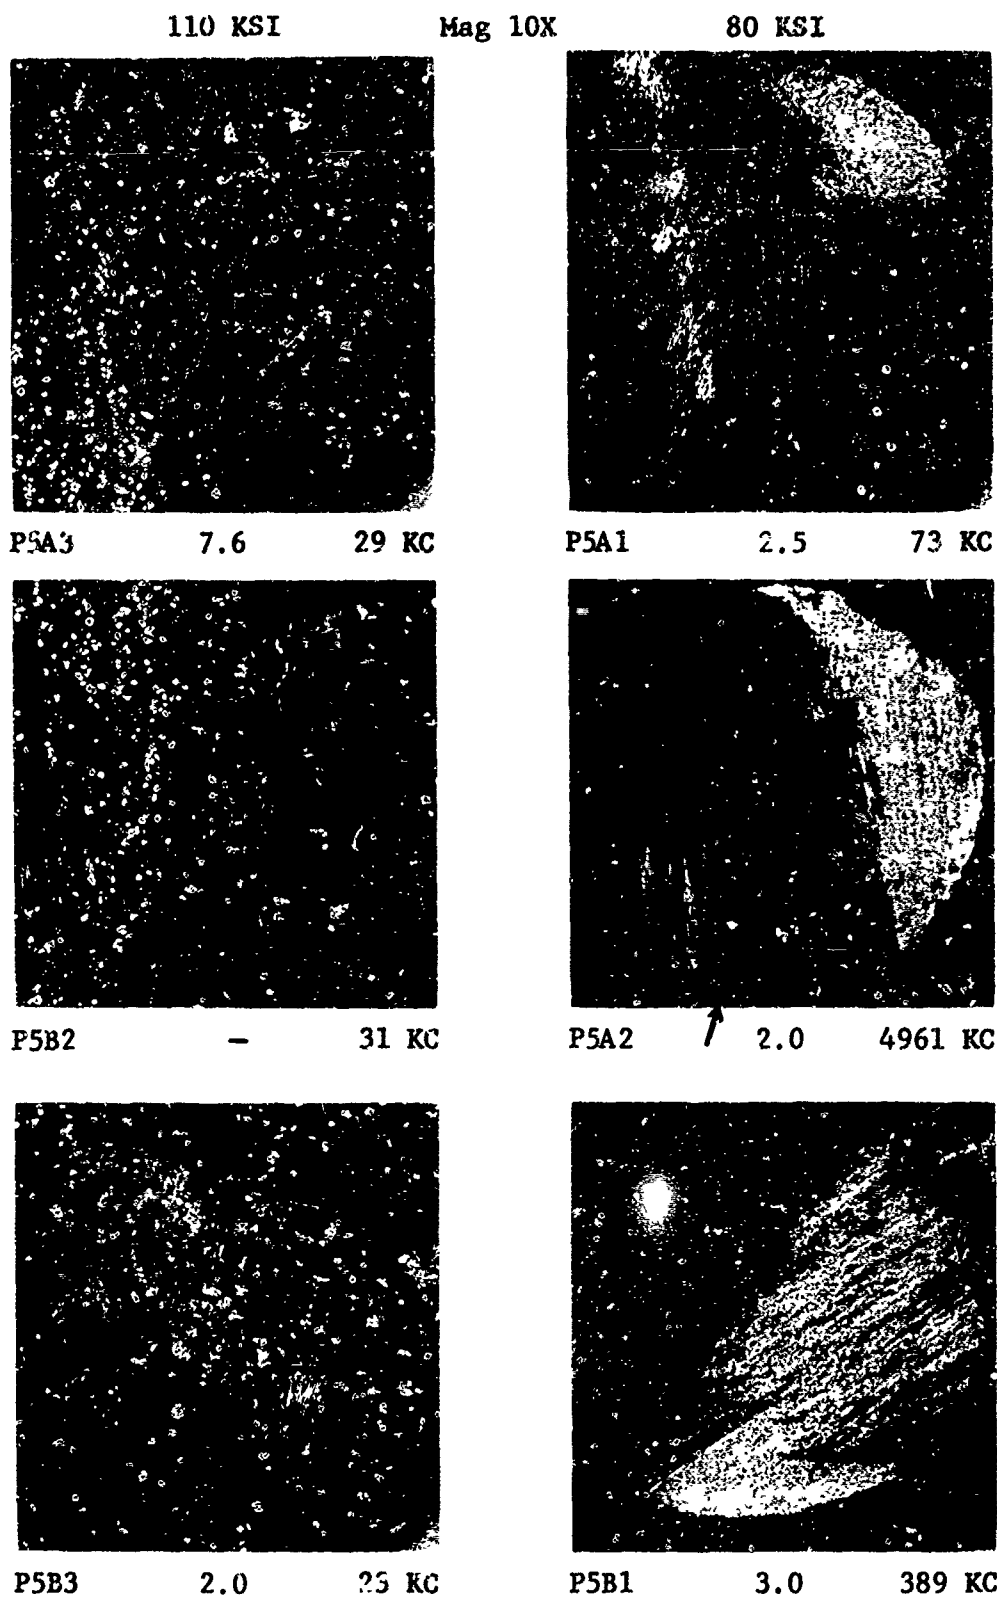
Figure 8.51 Fracture Surfaces of Failed Fatigue Specimens Series P5-Double-Bond/Two-Axis Diffusion Bonded with ASTM Grain Size No. 10

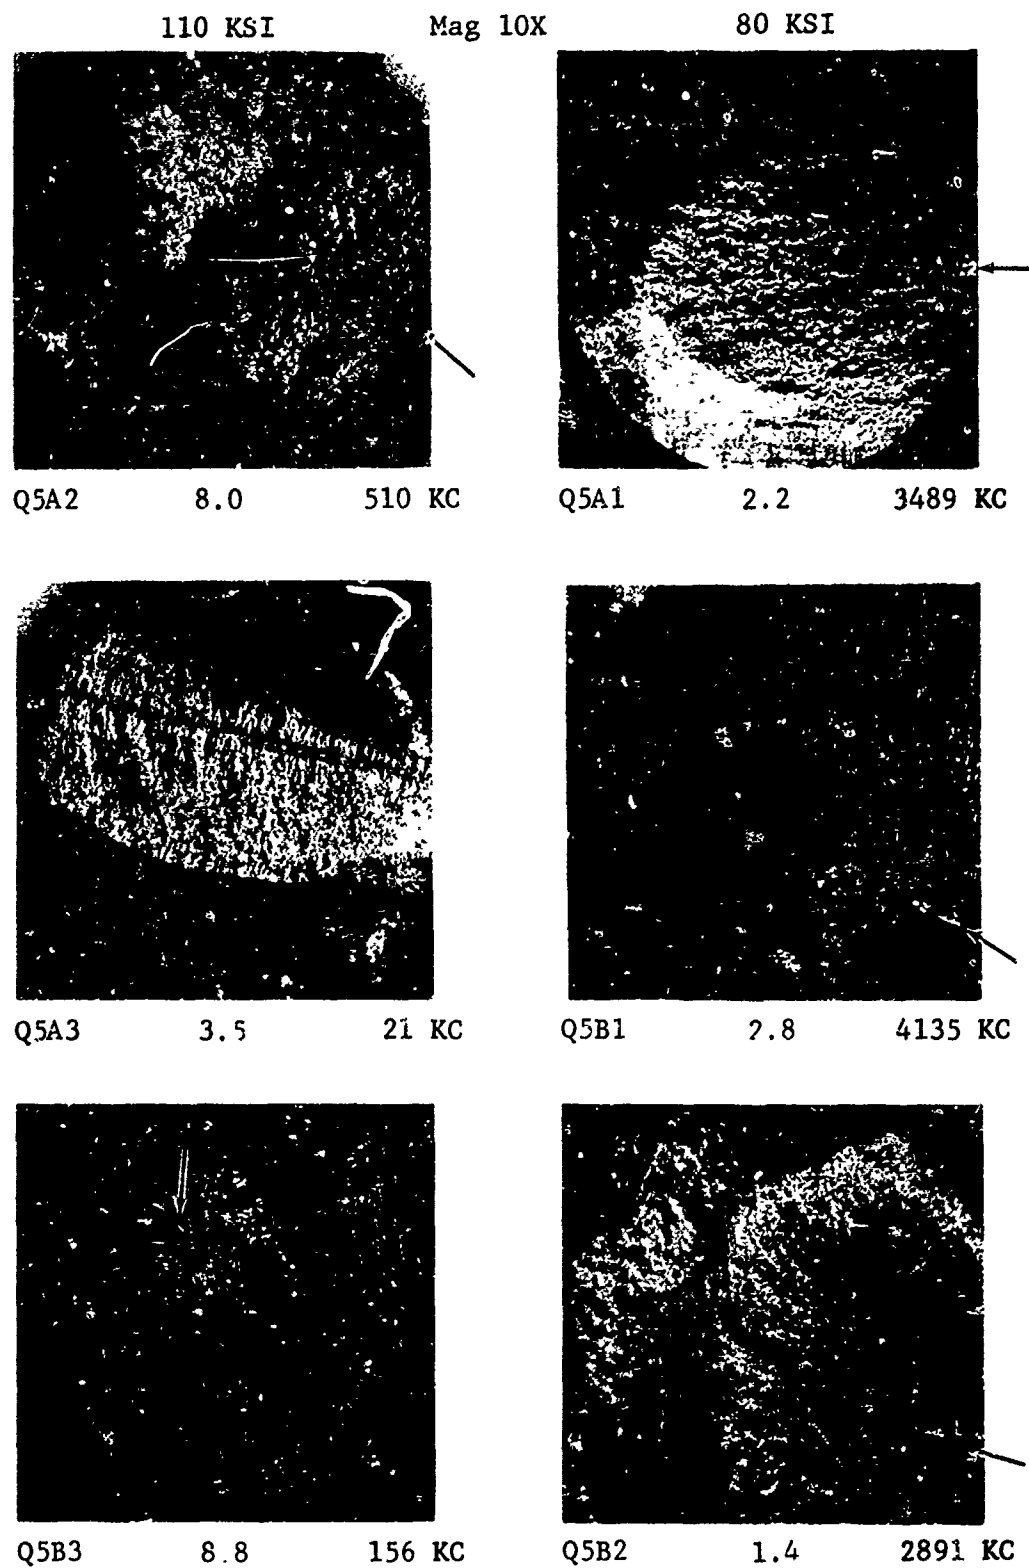
Figure 8.52 Fracture Surfaces of Failed Fatigue Specimens Series Q5-Double-Bond/Two-Axis Diffusion Bonded with ASTM Grain Size No. 8

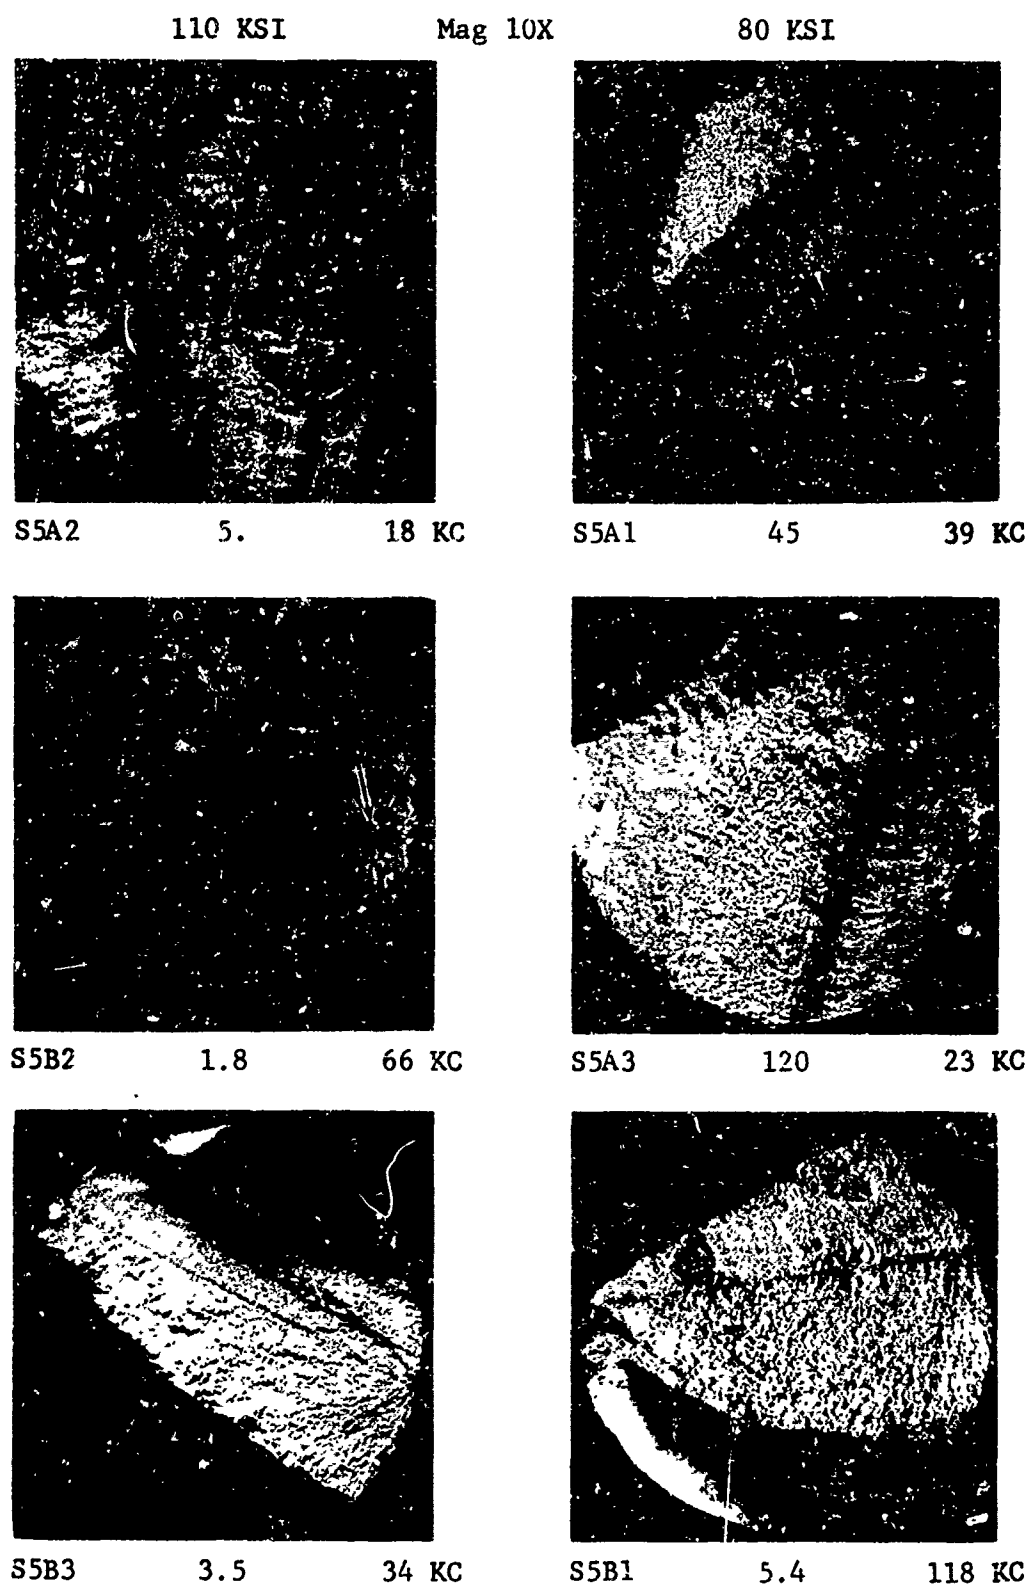
Figure 8.54 Fracture Surfaces of Failed Fatigue Specimens Series S5-  
Double-Bond/Two-Axis Diffusion Bonded with .005" Chamfered  
Edge Void

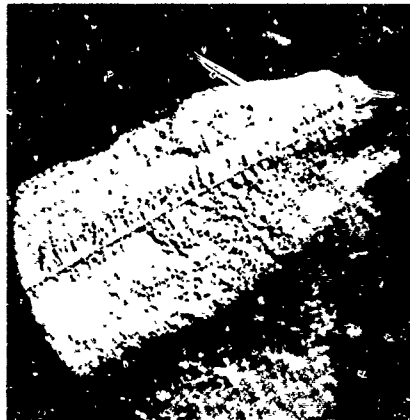
U5A2

Figure 8.47 Fracture Surfaces of Failed Fatigue Specimens Series U5-  
Double-Bond/Two-Axis Diffusion Bonded with .020" Chamfered  
Edge Void

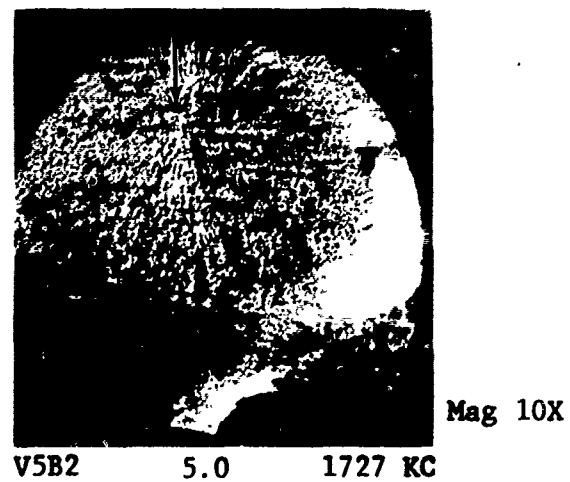
Figure 8.56 Fracture Surfaces of Failed Fatigue Specimens Series V5-Double-Bond/Two-Axis Diffusion Bonded with Alpha Case Contamination

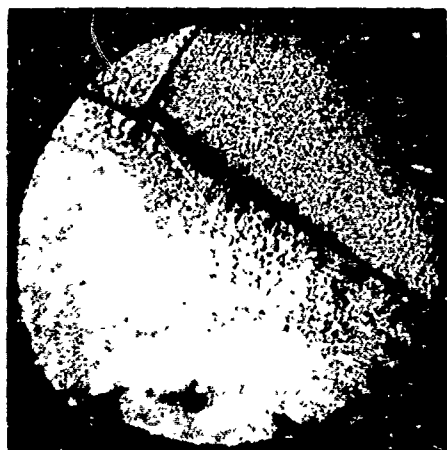
Figure 8.70 Fracture Surfaces of Failed Fatigue Specimens Series X6-Multiple-Bond/3-Axis Diffusion Bonded with  $\text{SiO}_2$  Powder Contamination

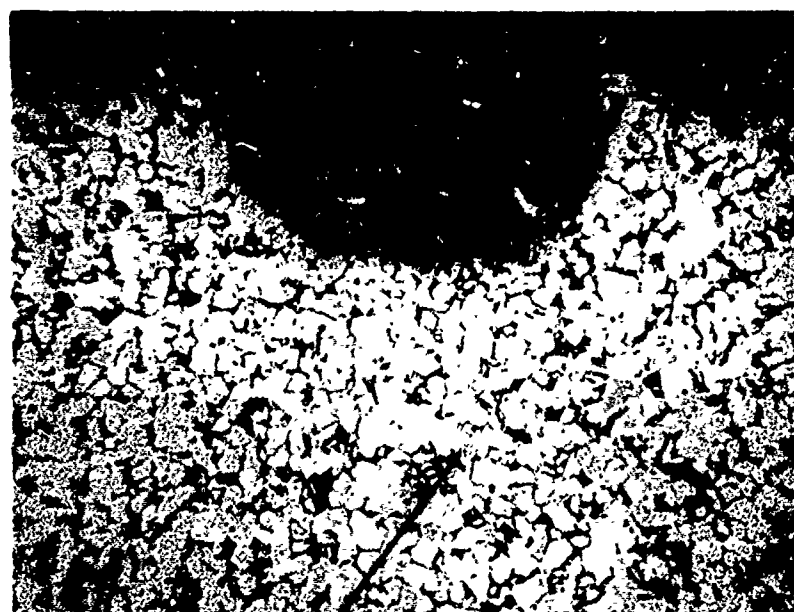
Top photo was taken of the fracture looking down into the hole. Cubic grain growth and slip planes can be seen inside hole. Photomicrograph shows that metallic growth has occurred from diffusion bonding temperatures and pressures.

Figure 8.71 Microstructure of Diffusion Bonded Ti-6Al-4V Specimen S3B2 Containing a .0065" Dia Electric Discharge Formed Hole

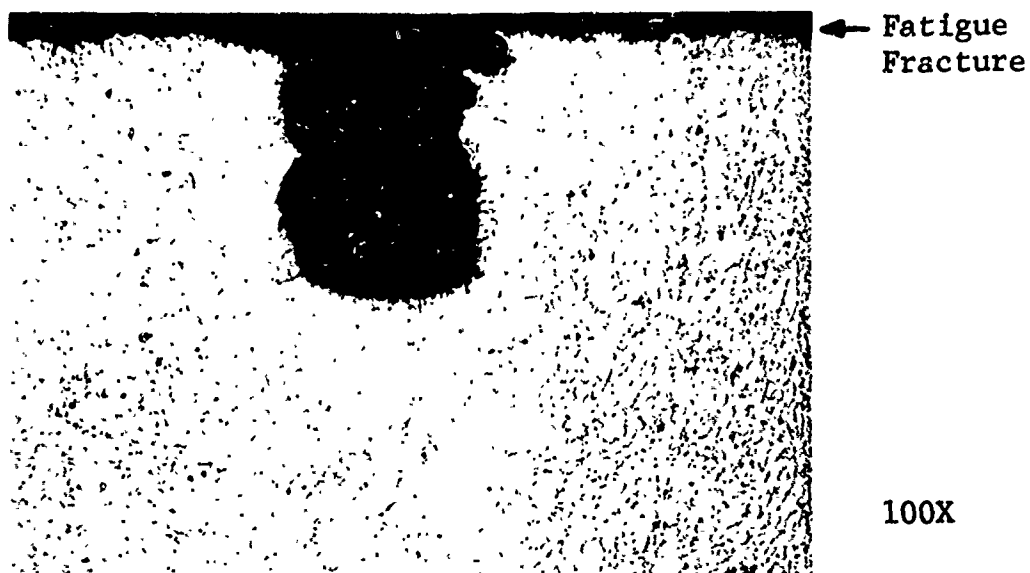
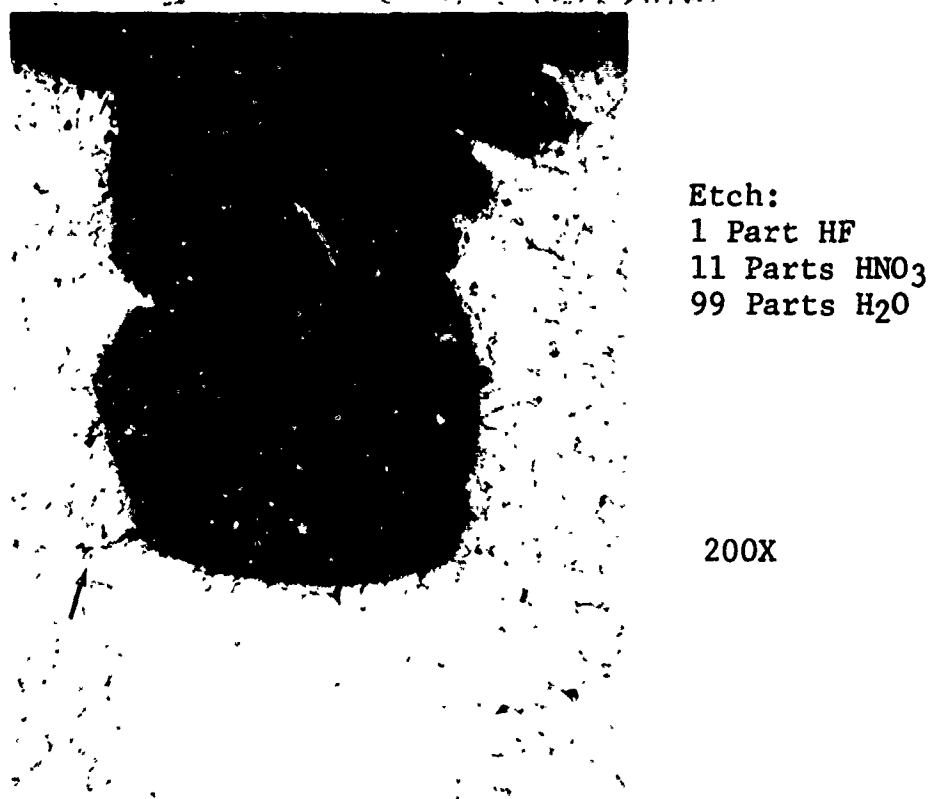
Although fatigue failure occurred at top of hole at diffusion bonded interface, a fatigue crack can be seen to have formed at bottom of drilled hole. Microsection not thru hole center-line.

Figure 8.72 Microstructure of Diffusion Bonded Ti-6Al-4V Fatigue Specimen U3B1 Containing Drilled .020" Dia. Void

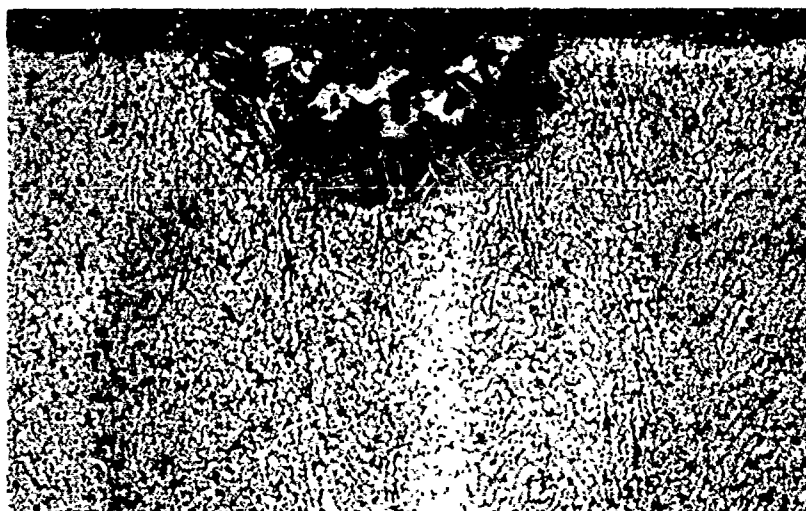
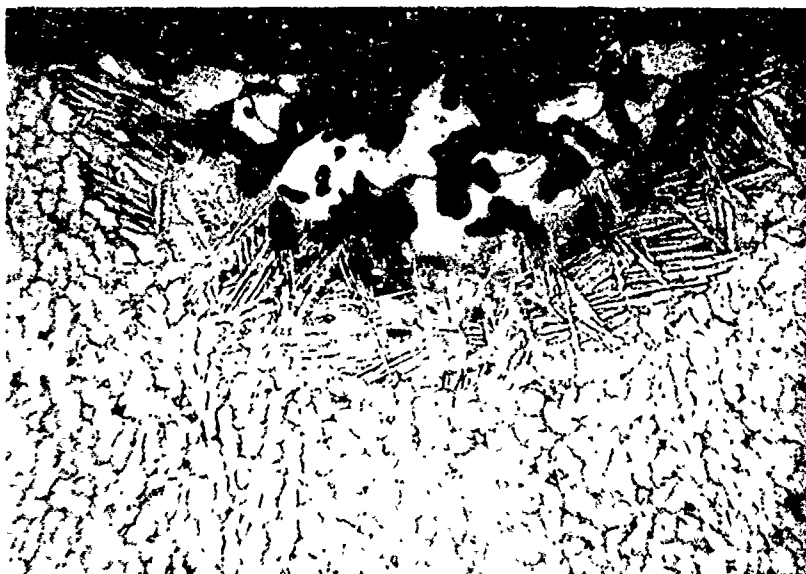
The defect resulted from filling an original .013" dia x .006" deep drilled hole with 304S.S. powder and bonding 6 hours at 1700F with 5% deformation. The 19% Cr and 58% Fe in the 304 diffusing into the Ti-6Al-4V lowered the beta transus, allowing transformation of the equiaxed alpha to beta at the 1700F bonding temperature. On cooling, part of this beta was retained (dark etching constituent) adjacent to the coalesced 304 powders. The remainder of the converted beta transformed to acicular alpha forming the .004" deep layer shown above.

Figure 8.74 Microstructure of Diffusion Bonded Ti-6Al-4V Specimen W3B2 Containing 304S.S. Powder Defect at the Bond Plane

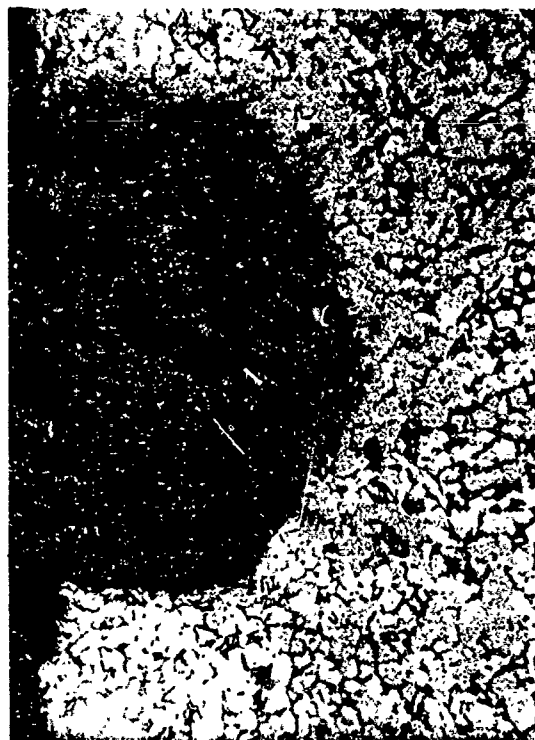
B.  $\text{SiO}_2$  in Hole Reacted Very Slightly with Ti to Form More Beta (200X)

Figure 8.75 Microstructure of Diffusion Bonded Ti-6Al-4V Specimen X3A1 Containing  $\text{SiO}_2$  Powder in Drilled .013" Dia. Hole

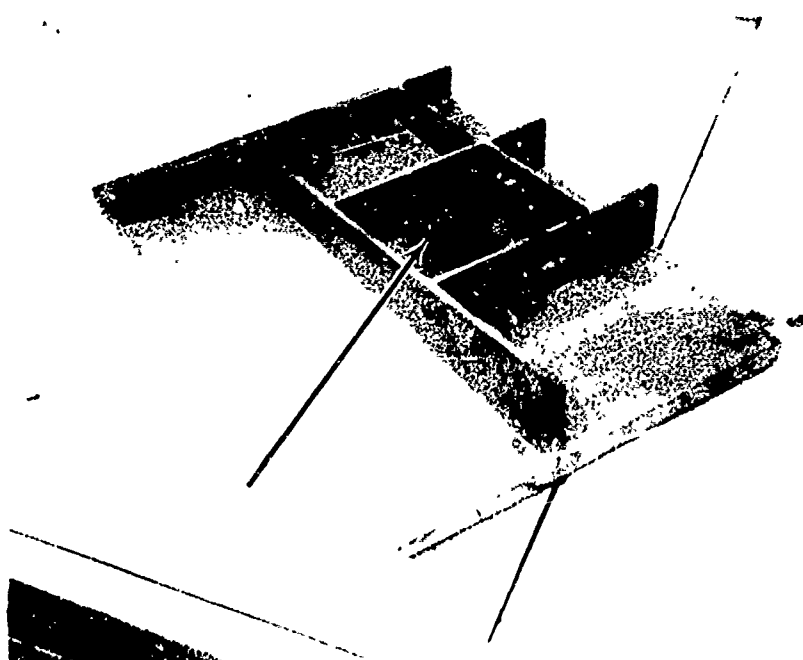
Part #2 - A small flaw indication was detected in a fillet area close to the thin wall in the middle of the specimen (see Figure 9.7). This flaw indication was sufficiently small that no further diagnostics were attempted.

Figure 9.7 Fluorescent Penetrant Record of Part #2 with Location of Flaw Indication

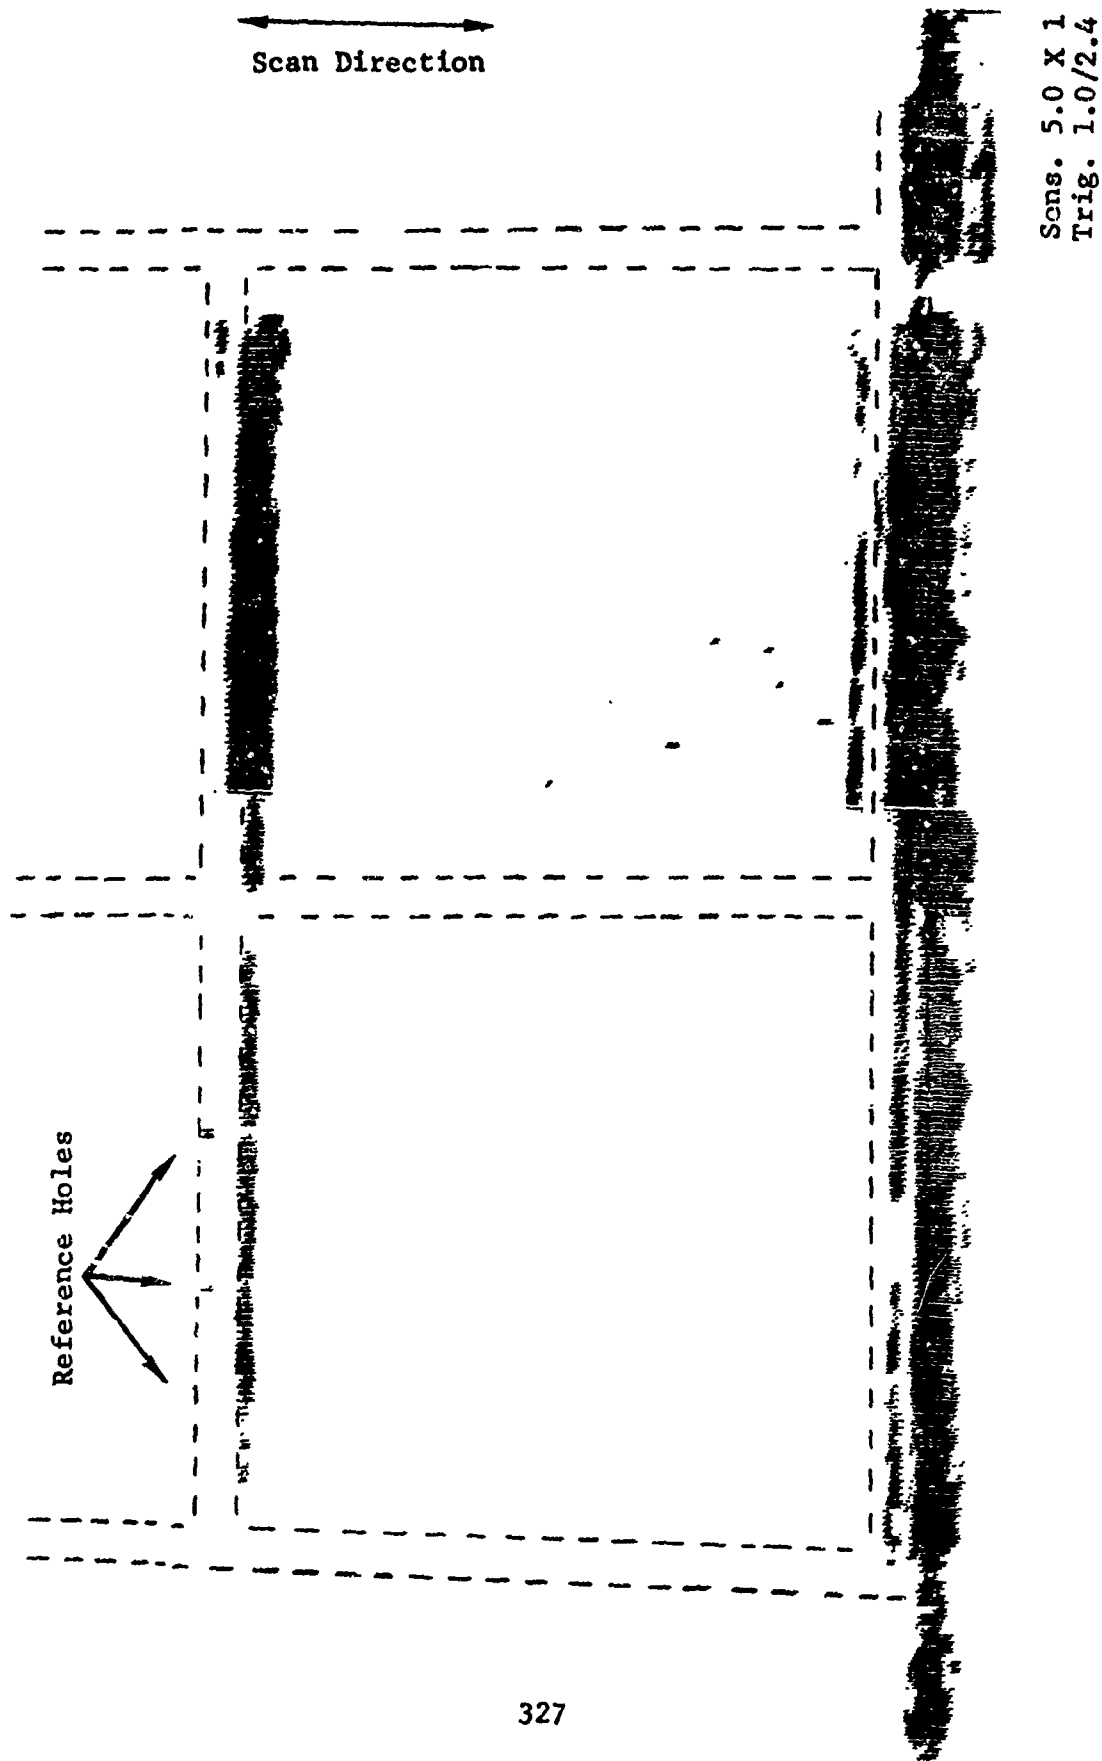
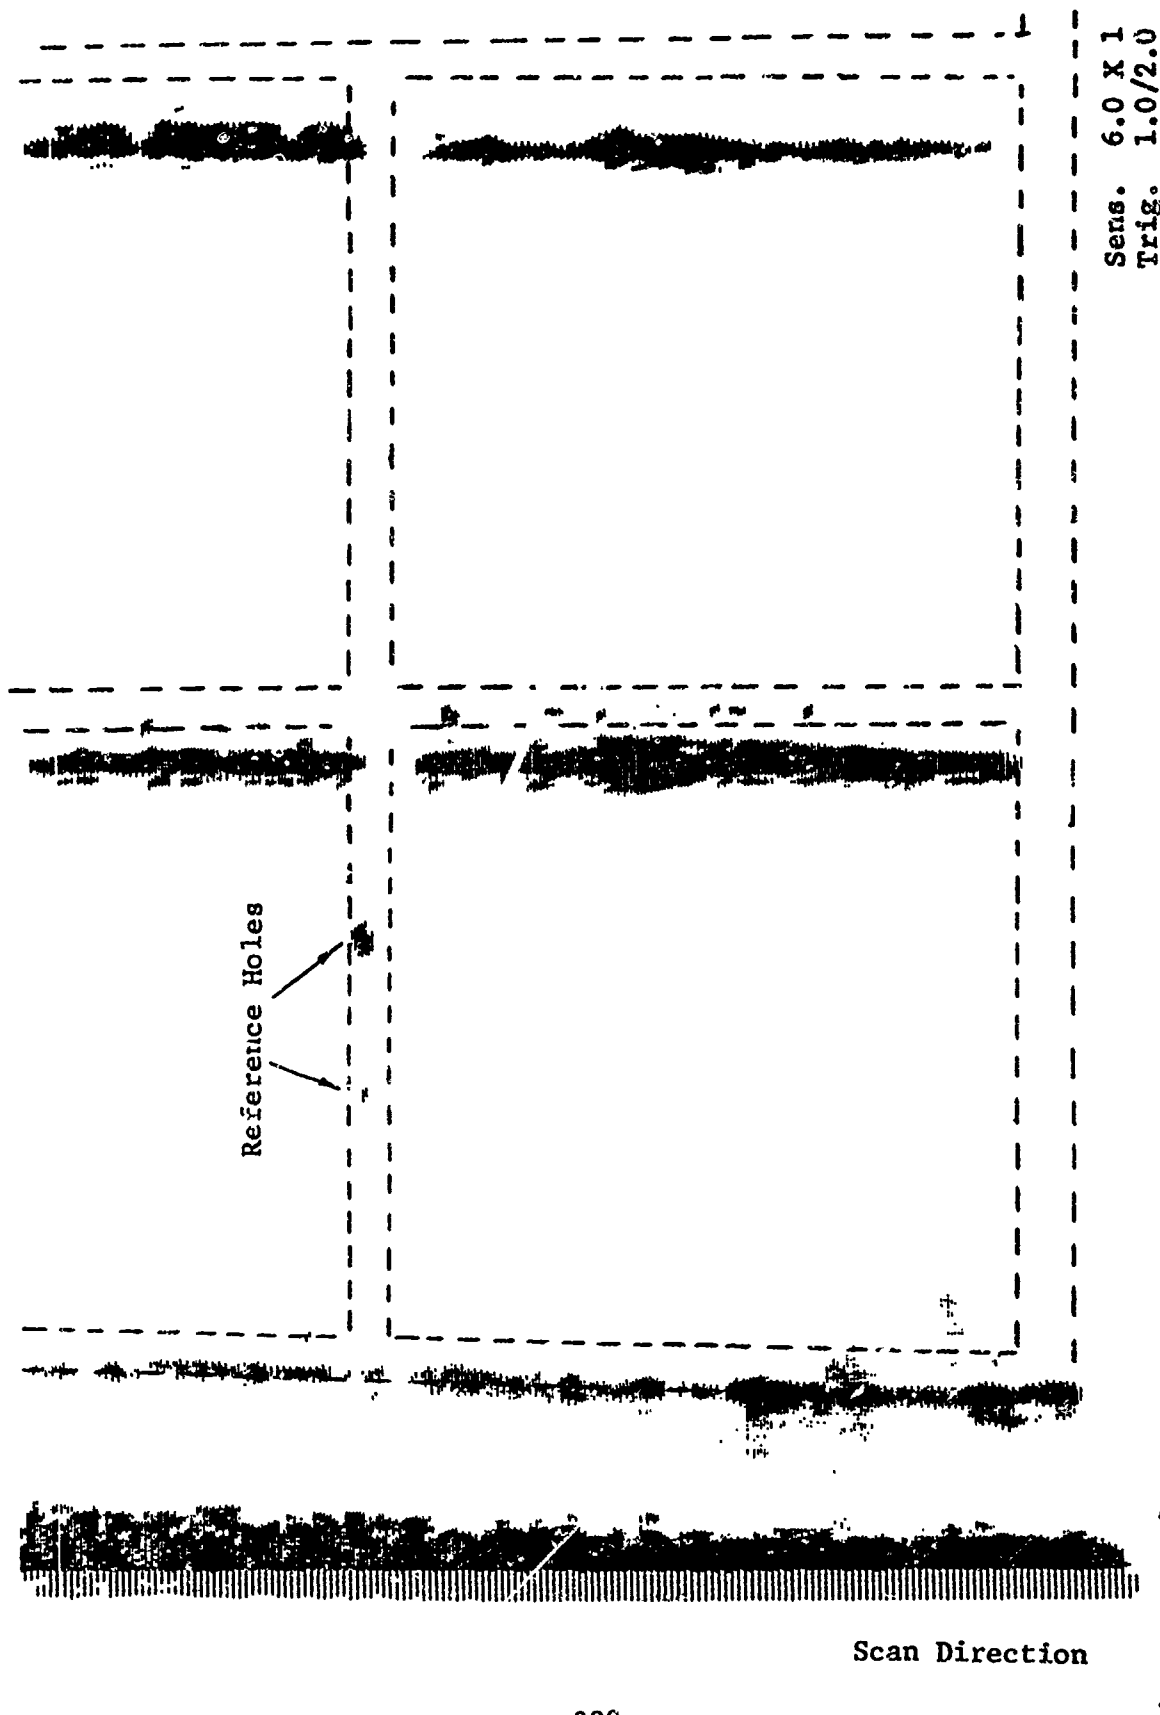
Figure 9.11 Delta/C-Scan Record of Part #1

Figure 9.12 Delta/C-Scan Record of Part #1 (90° Rotation)

The linear indications aligned with the ribs are returns from the fillet radii. Indications in the bond areas will be correlated with the results of the other modes of ultrasonic inspection described in the next sections.

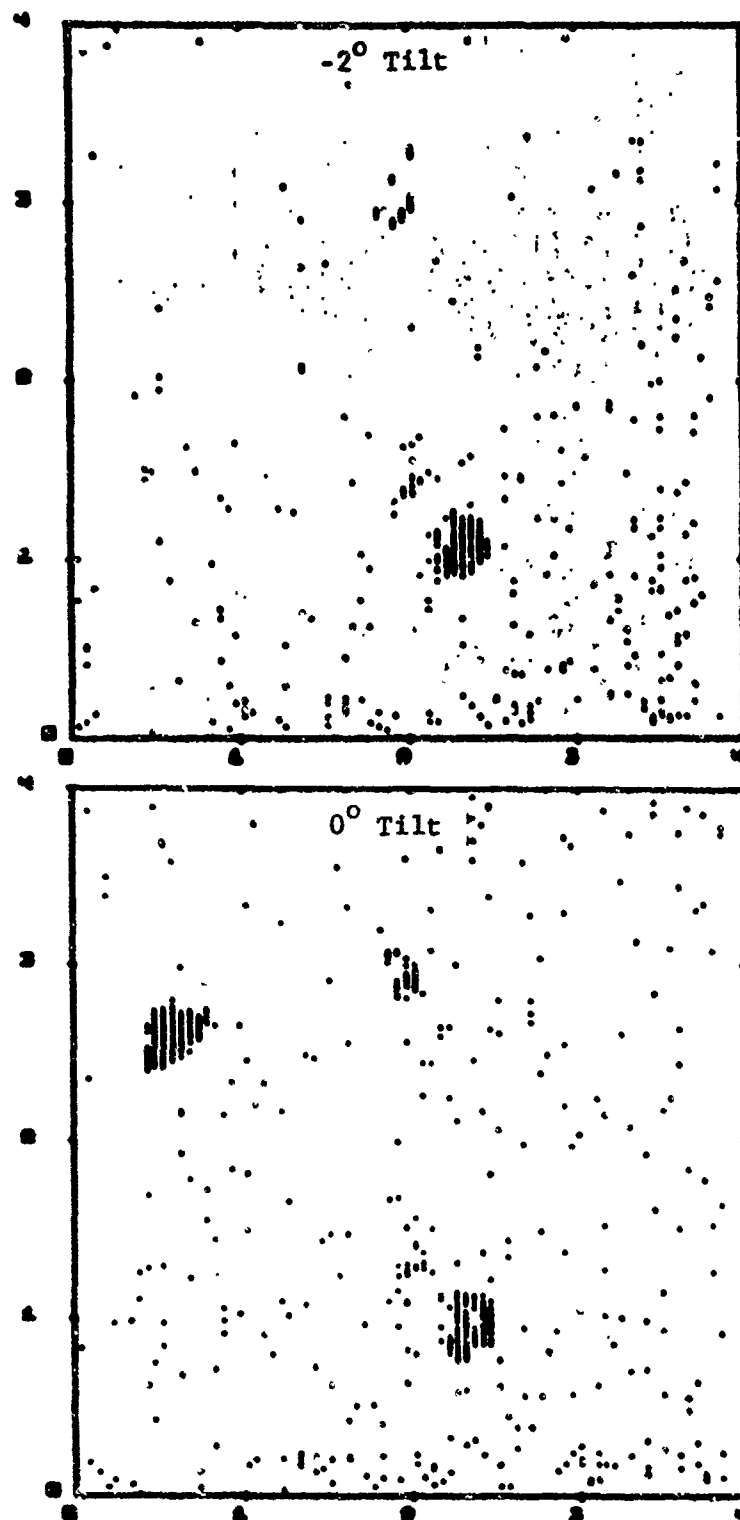
The scan records at  $-2^{\circ}$  and  $0^{\circ}$  (Figure 9.15) indicate the presence of the 3/64-in. dia. drilled hole between the two flat-bottom holes which do not appear. This re-emphasizes that conventional C-scan ( $\theta = 0^{\circ}$ ) is inadequate for inspecting displaced and angularized bond planes.

Figure 9.15 Flaw Display in Reference Hole Area of Part #1  
(Transducer Inclination,  $-2^\circ$  and  $0^\circ$ )

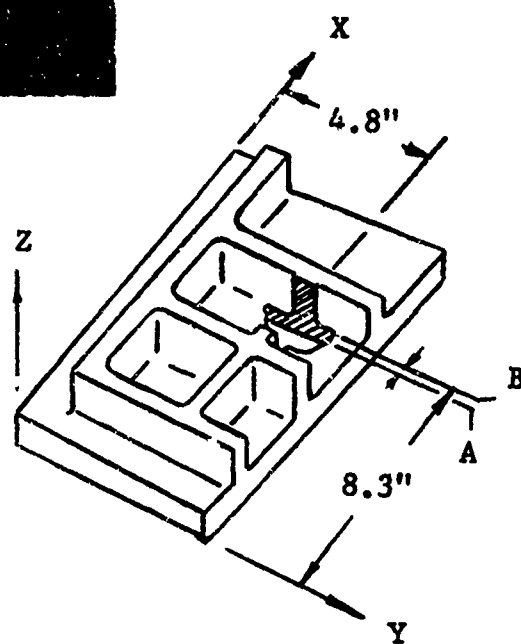
Figure 9.21 Photomicrographs of Microstructural Anomalies in Bond Plane of Part #1 at  $X = 8.3$  in.,  $Y = 4.8$  in.

Part #1 was sectioned at location  $X = 8.3$  in.,  $Y = 4.8$  in. Two sections  $1/8$ -in. apart in the Y-Z plane were polished and etched. Figure 9.21 shows the sections related to Part #1 and the corresponding microstructural features. Connected grain boundaries generally perpendicular to the Z-axis are visible in Section A. Section B in Figure 9.21 exhibited a clearly defined elliptic area with major and minor axis dimensions of 0.24 in. and 0.15 in., respectively.

The results of microhardness traverses across the elliptic area are given in Figure 9.22. A maximum point-to-point difference of over 200 Knoop Hardness numbers was observed. This ranged from 452 KHN (Rockwell C44) in an alpha case area to 235 KHN (Rockwell C20) in the elliptic area. Hardness in the parent material is 335 KHN (Rockwell C33).
